# MINERALS

FEBRUARY, 1970

## ROAD LOG – STORM-DAMAGED AREAS IN CENTRAL VIRGINIA

H. W. Webb, W. E. Nunan, and H. M. Penley

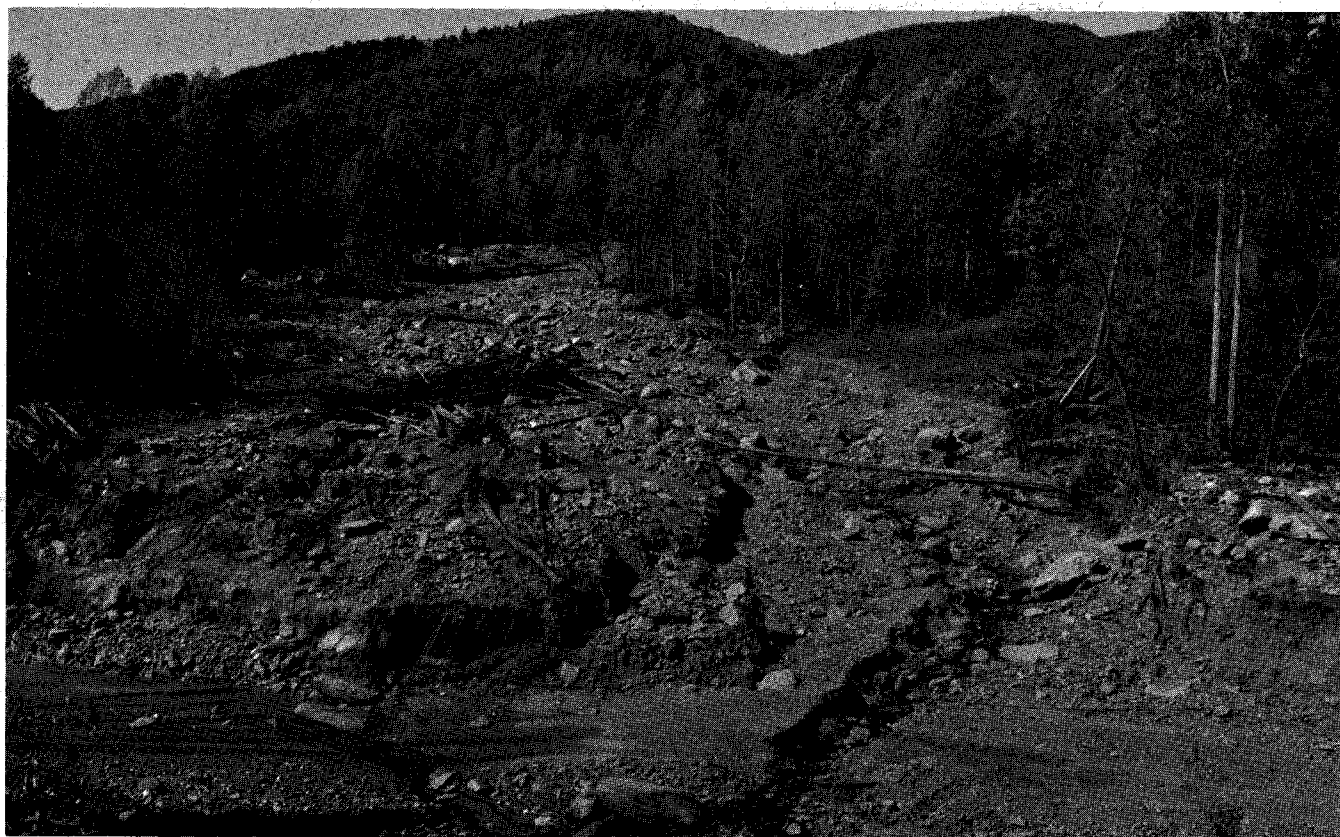
Figure 1. Boulders and gravels disgorged from hillside ravines and deposited along a slope adjacent to Davis Creek. About 3.7 miles southwest of Woods Mill.

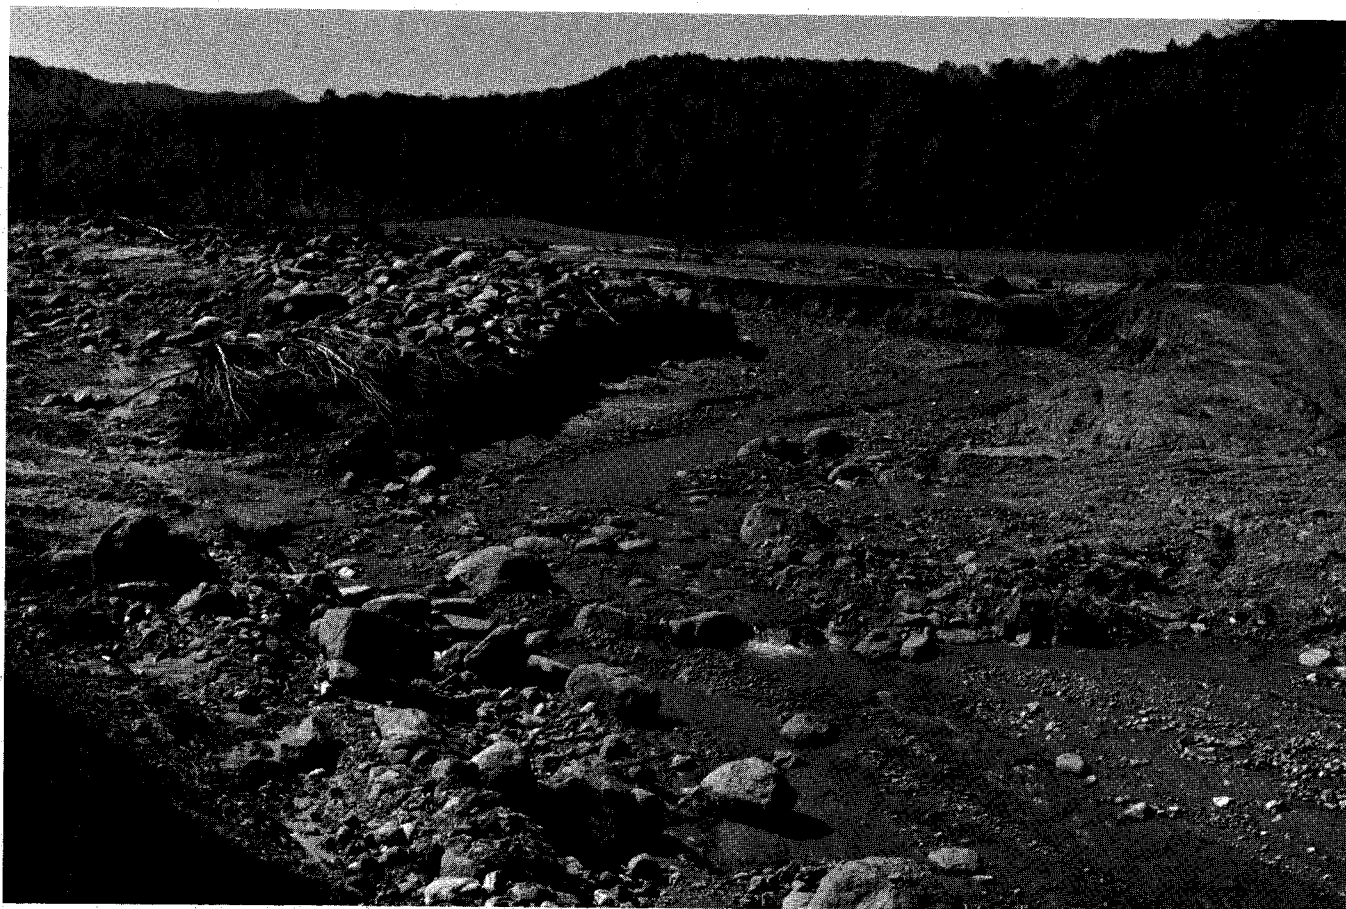
5.7	0.6	A debris fan is present in a tributary across Davis Creek. Some sorting is evident in the material that constitutes the fan; cobble, gravel, and sand debris tend to occupy the areas adjacent to channels and these deposits are flanked by boulders. Stacking of the debris in a downstream direction is suggested by the attitude of planar boulders and cobbles. Boulders in these fans have dimensions as large as 15 by 10 by 7 feet. Both well-rounded and angular fragments are present (Figure 1). Boulders in the valley of Davis Creek are as large as 11 by 10 by 7 feet. Stream scouring produced vertical banks up to 12 feet high. Two soil profiles with ancient flood-plain deposits are exposed in the bank (Figure 2; No. 7).

Figure 2. Deposition of a boulder cap (left center) on pre-existing alluvial material, a portion of which was subsequently eroded. Gravels were exposed at the base of the incised stream bank (upper right). About 3.7 miles southwest of Woods Mill.

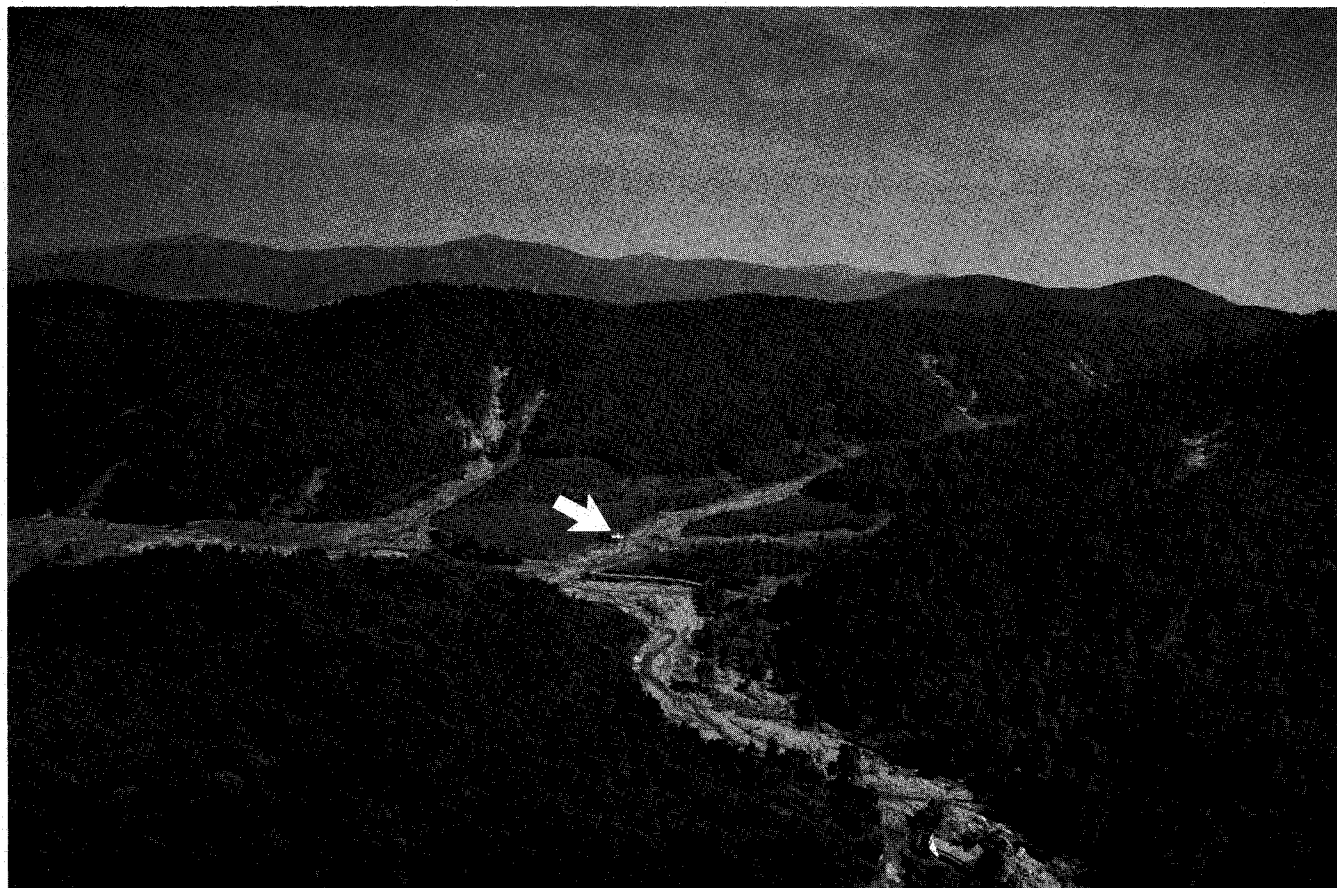
6.4	0.4	Coalescing chutes (located near the center of Figure 3) are present to the left of State Road 623.
6.5	0.1	Boulders and log debris on the left along tributary to Davis Creek; house damaged here (Figure 4).

Figure 3. Several chutes developed below ridge crests during debris avalanches (midground and background). Boulders and tree trunks were strewn along Davis Creek. About 4.5 miles southwest of Woods Mill. House in orchard area (see arrow) illustrated in Figure 4.

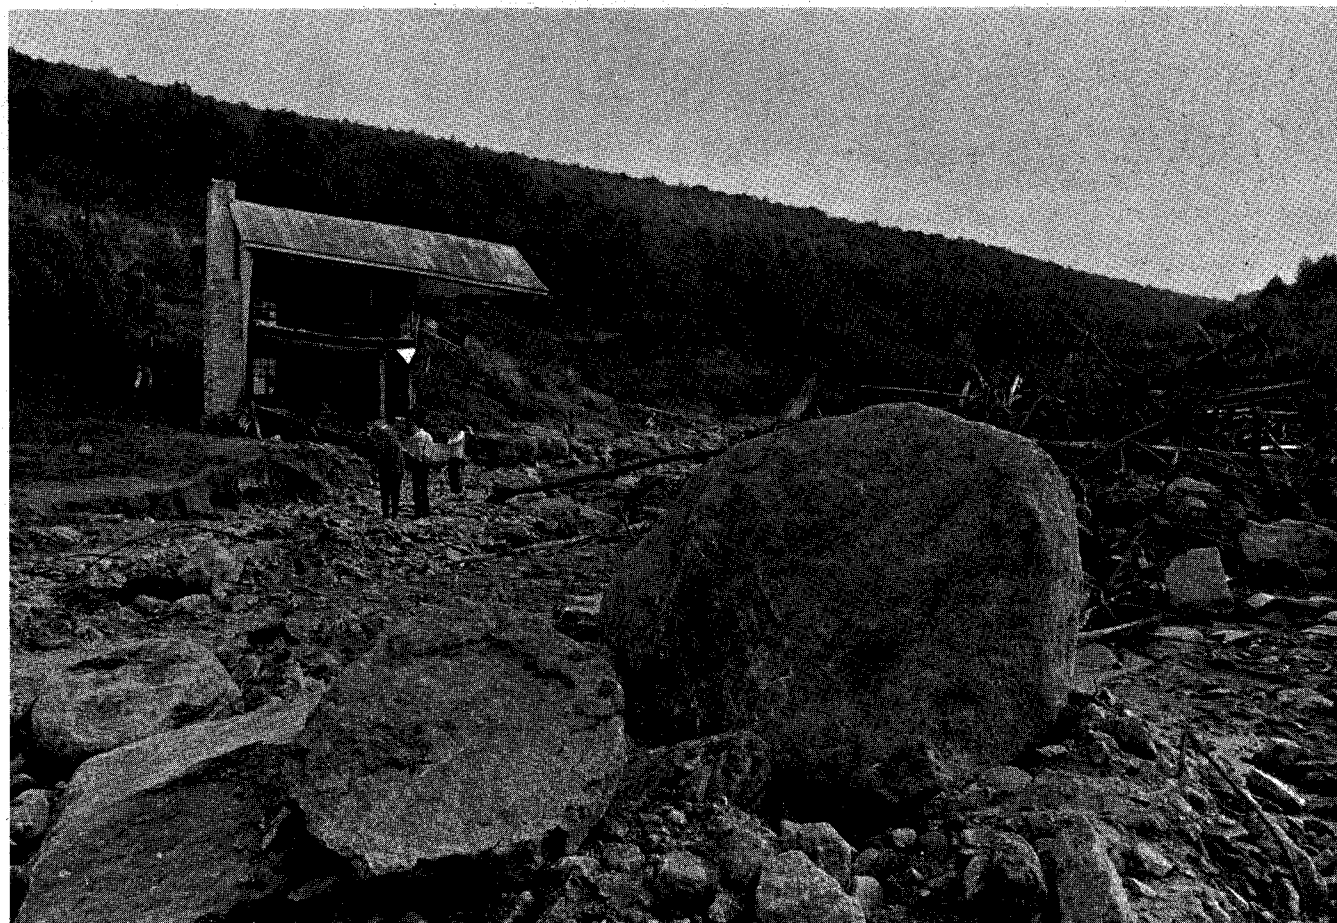
Figure 4. Portion of home destroyed by debris-laden torrent. Large boulder in foreground is approximately 5 feet in diameter; bedrock below unsupported section of roof was exposed by flood water. Along a tributary to Davis Creek about 4.5 miles southwest of Woods Mill.

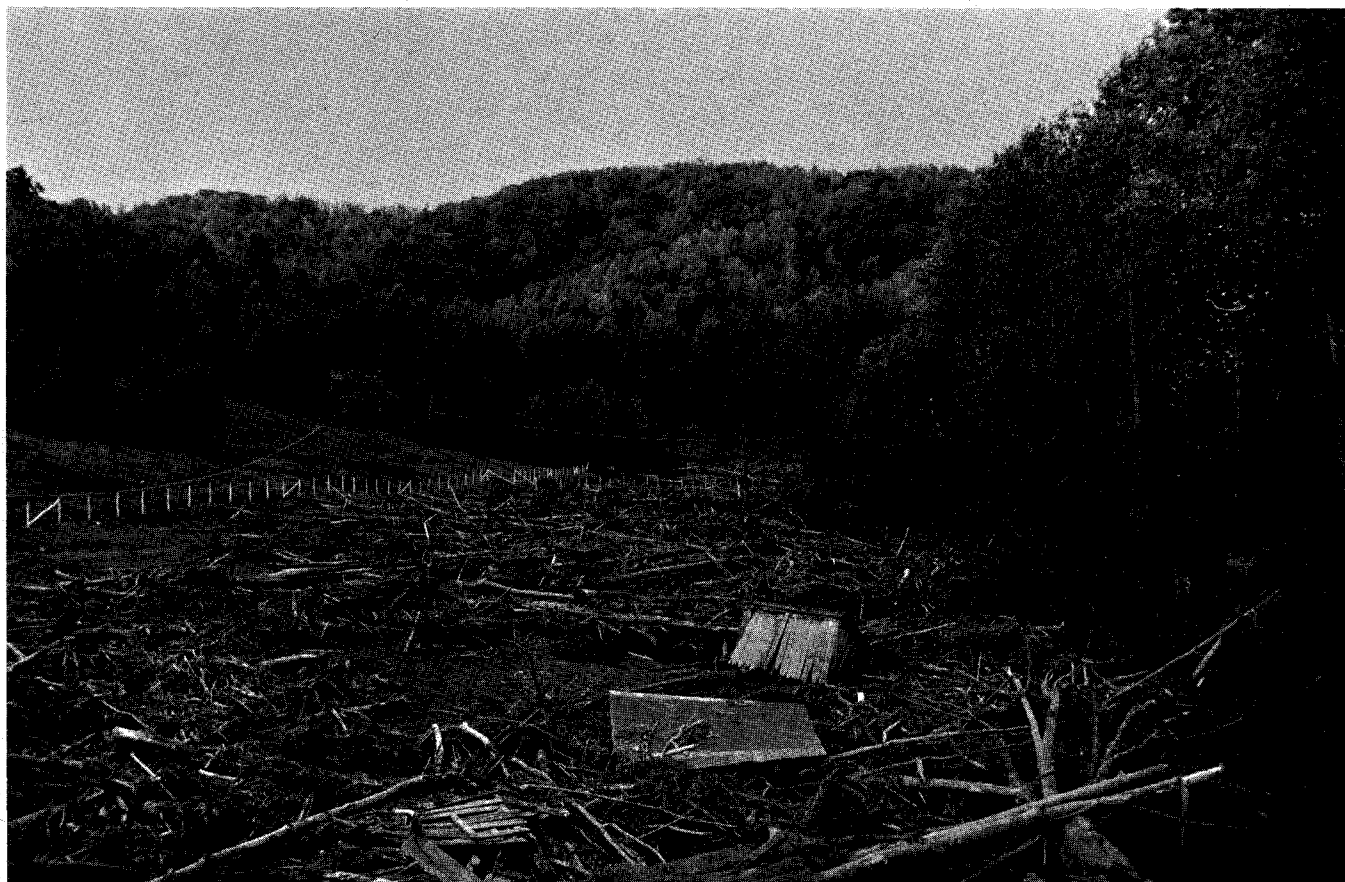
15.2	0.1	Town of Lovington.
15.3	0.1	Log debris in stream valley to the left (Figure 5).
16.4	1.1	Junction of U. S. Highway 29 and 29 bypass; take bypass. Chutes are developed on mountain slopes to the right and left of the highway.

Figure 5. Mat of jumbled tree trunks in the valley of a small tributary to Muddy Creek. Recession of the water after temporary ponding resulted in settling of debris on a surface of silt and mud. Fence posts were emplaced after flood. Along U. S. Highway 29, Lovingson.

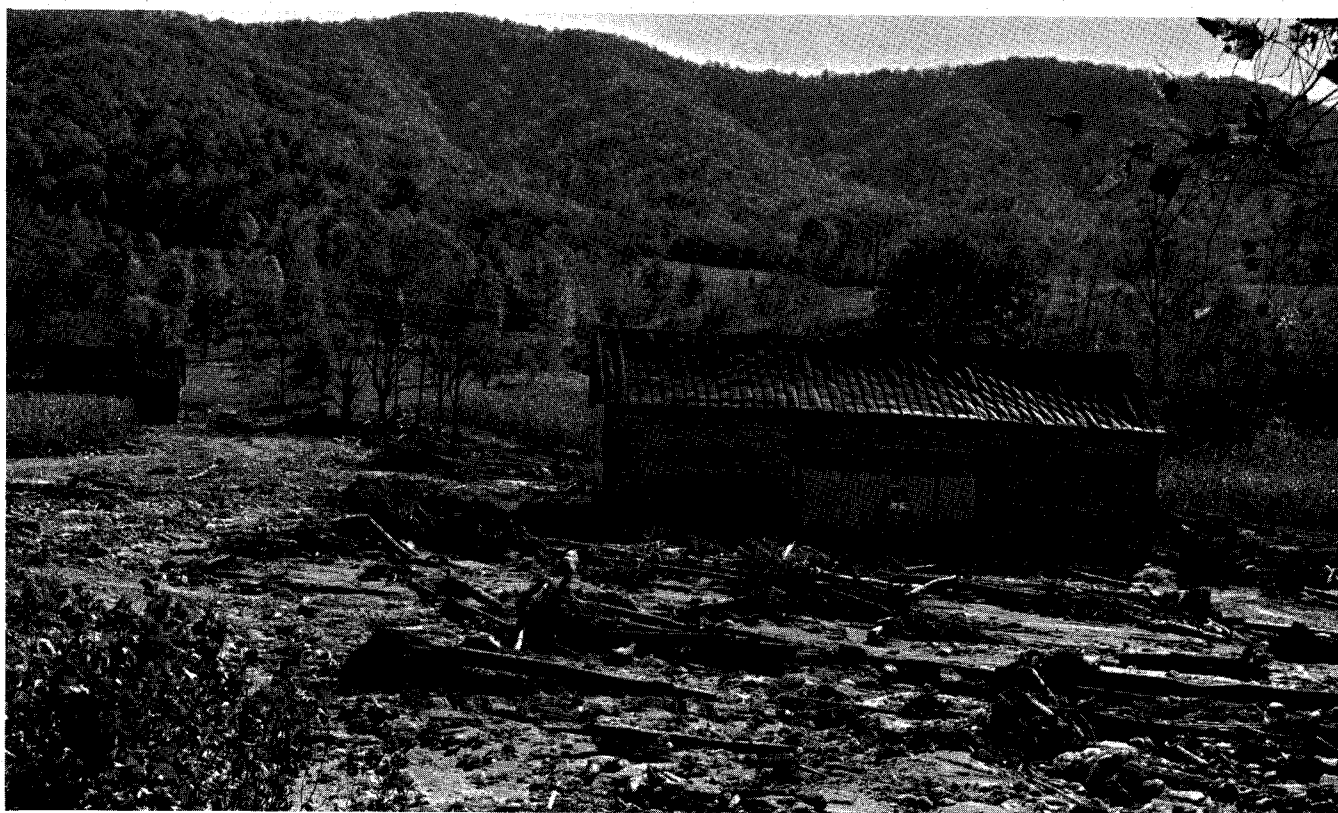
30.8	0.1	The road was washed out where it crosses a tributary to Hat Creek.
31.3	0.5	Junction with State Highway 151 at Bryant; turn left on State Highway 151. A side trip can be taken to the northeast along State Highway 151 for about 4.5 miles. There are numerous chutes on the mountainsides and extensive deposits of debris along Hat Creek (Figure 6).

Figure 6. Frame structures distorted by force of rampant flood water that caused development of billowy wrinkles in metal roofs. Tree trunks (foreground) were aligned with direction of water flow. Near headwaters of Hat Creek about 2.4 miles northeast of Bryant.
